# **Bel Air Impoundment Breach Analysis Report**

Harford County, Maryland

**Maryland American Water Company**

Gannett Fleming Job No. 059267

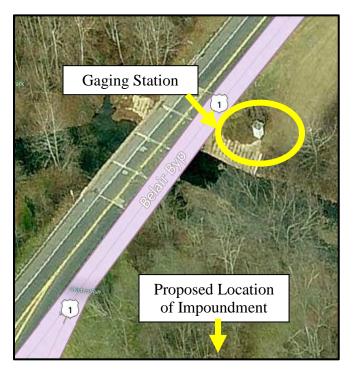
Figure 2 - USGS gaging station at Winters Run near Benson, MD

The USGS software program PeakFQ was used for frequency analysis of stream discharge observations retrieved from the USGS gaging station at Winters Run near Benson, MD (Station ID 01581700). As illustrated in Figure 2, this stream gage is located near the Route 1/Bel Air Bypass crossing of Winters Run immediately adjacent to the northern-most portion of the proposed embankment and about 2,000 feet upstream of the existing raw water intake. The stream gage has a continuous record of peak streamflow since 1967, providing 48 years of record for the analysis. The 2-year and 100-year discharges in Winters Run as estimated by the PeakFQ gage analysis are 2,427 and 13,760 cfs, respectively. Analysis results are presented in Appendix B-2.
